Solar Farm Inspection Report — May 2025

4,218 Panels Inspected	37 Defects Found	8 Critical
----------------------------------	----------------------------	----------------------

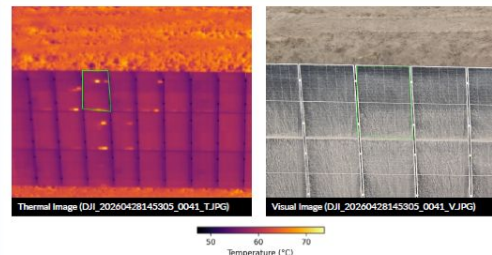
Anomaly ID: 3

CRITICAL

Anomaly Type	Multi hotspots
Anomaly Cause	Soiling or dirt
Severity	Critical
Panel-No	26-1-4-A

Min Temperature	17°C
Max Temperature	85°C
Mean Temperature	48.46°C
Delta Temperature	41°C

Due: ASAP

Perform field inspection and cleaning. Measure module electrical parameters to check for performance loss. Monitor the module over time for any negative changes.
